# FEED HOPPER ADJUSTMENT AND MAINTENANCE

## INTRODUCTION

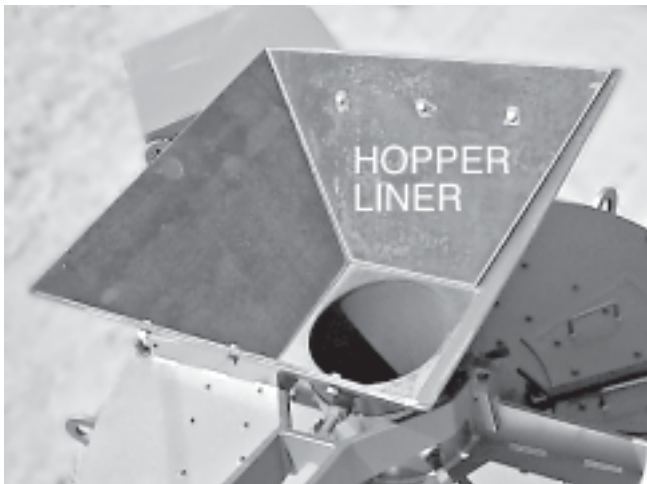
*Feed hopper liner*

Replace the feed hopper liners when they wear through and the hopper starts to appear behind them. Simply remove the three cap screws, lift off the plate, and replace it. Most likely the cap screws will need replacement also.

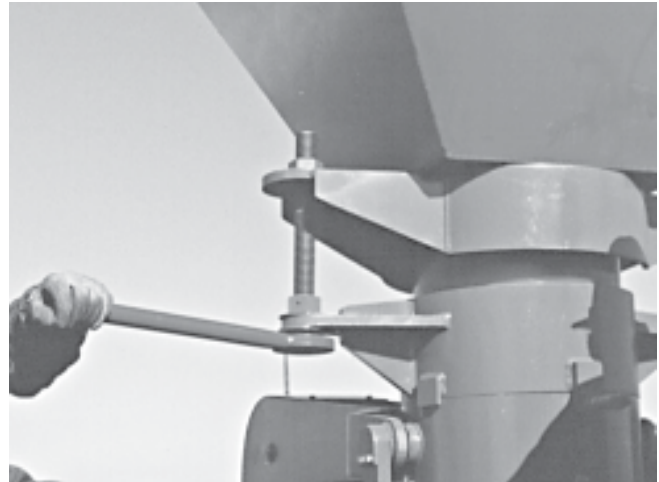
*New style hopper adjustment*

CEMCO introduced a new feed hopper in 1997. It adjusts up and down by turning a couple of large ACME thread screws. Follow these instructions to raise and lower the hopper.

1. Loosen the lid screws.
2. Use the wrench provided to rotate the adjustment screws. Turn the screws clockwise to lower the hopper and counterclockwise to raise the hopper. If the hopper needs to move a large distance, alternate between screws by giving one a turn then the other a turn.
3. Secure the feed tube in position and center it in the rotor by tightening the square head lid screws.

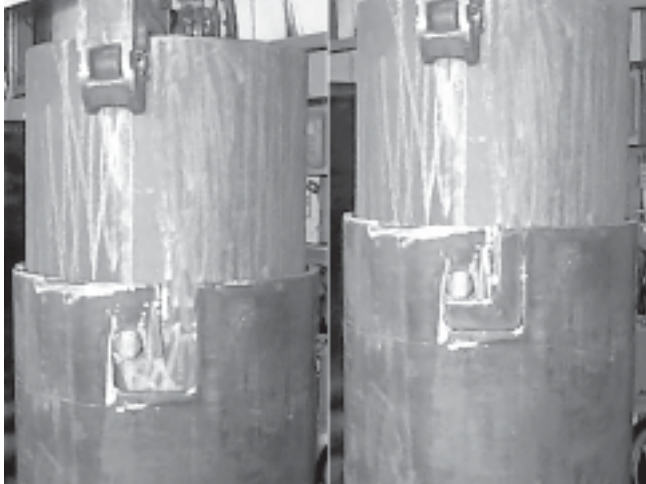
*Tab removed*

The feed tube liner installs in the feed tube through four J-shaped slots. Once installed, the tabs cut from the slots are tack welded back in place with short, low penetration welds. To remove the feed tube, grind off the welds and remove the tabs. Insert the new feed tube liner and tack weld the tabs back in place.

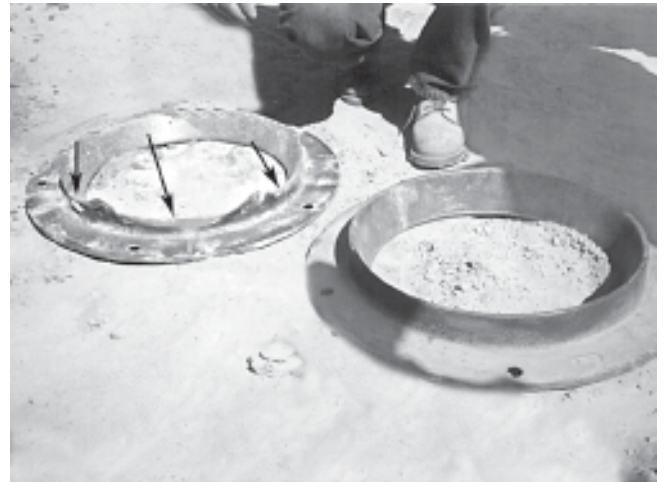
*The feed tube liner above caused excessive tube flange wear. This tube flange lasted only 16 hours.*

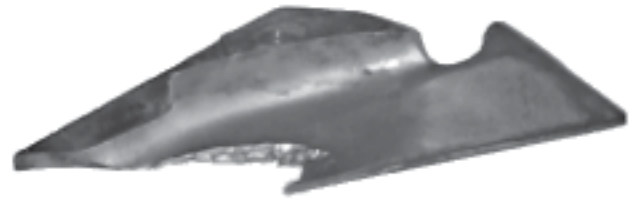
*This upper ramp was in the same rotor as the tube flange pictured above.*

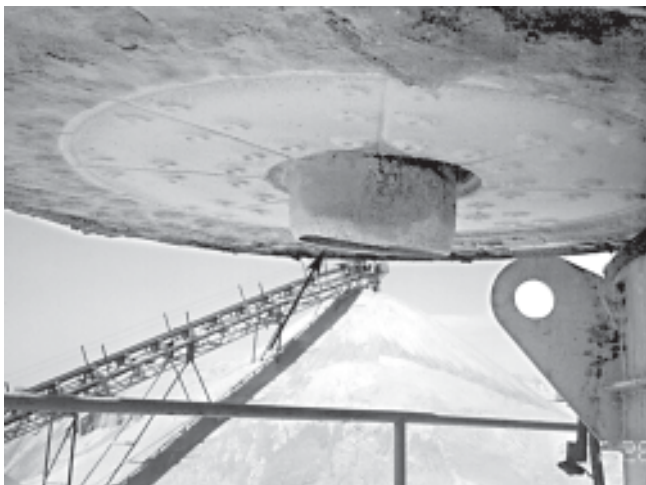
*Non square feed tube liner improperly directs material into the rotor. This results in excess tube flange and upper ramp liner wear.*

The feed tube or feed tube liner directs material into the crusher rotor. Proper maintenance and adjustment maximizes casting life and results in more effective and efficient crushing.
